Case Studies

California Wildfire 2003 & 2007

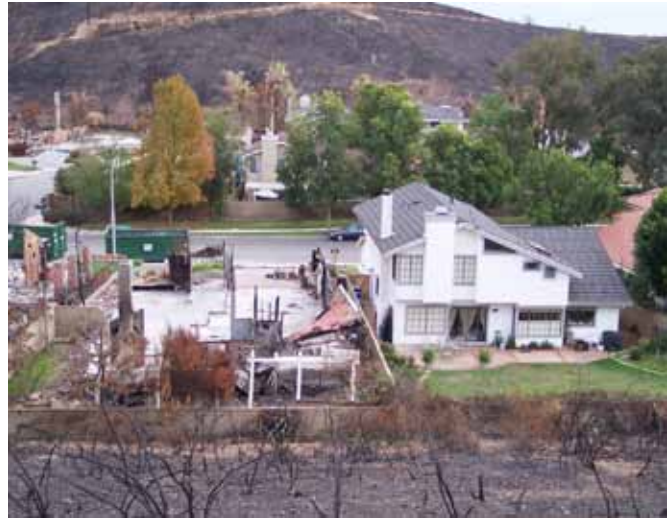
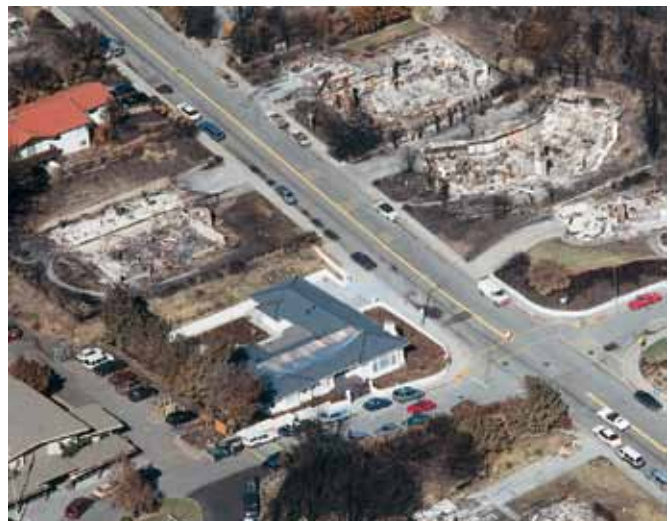
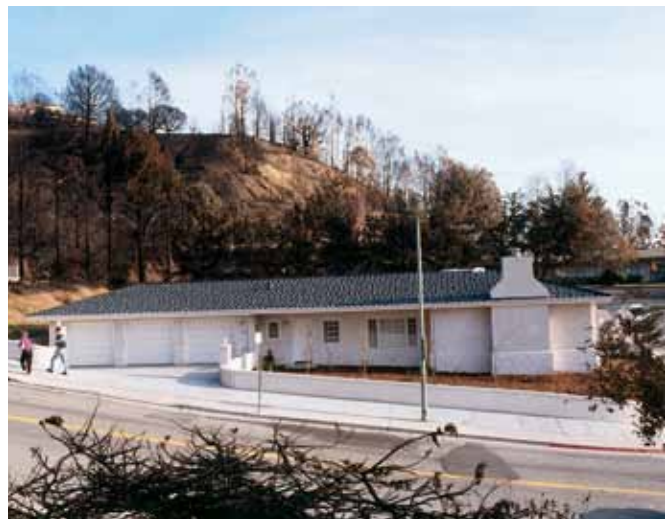
Stone coated steel is non-combustible and safe from exposure to airborne embers. The patented interlocking fastening method prevents the panels from lifting and allowing blowing embers to ignite the roof deck.

Most forest fires decimate residential communities through burning pine needles and windblown embers from roof to roof. More conventional roofs, such as asphalt, catch fire relatively easily and the home subsequently burns to the ground. With a stone coated steel roof, however, those same homes could be saved.

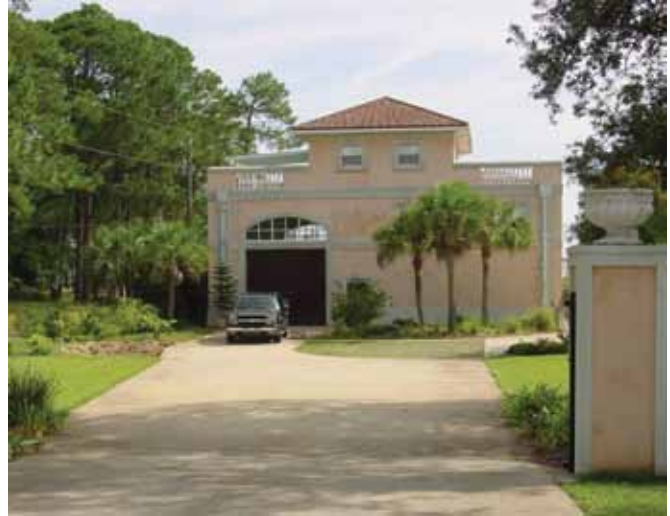
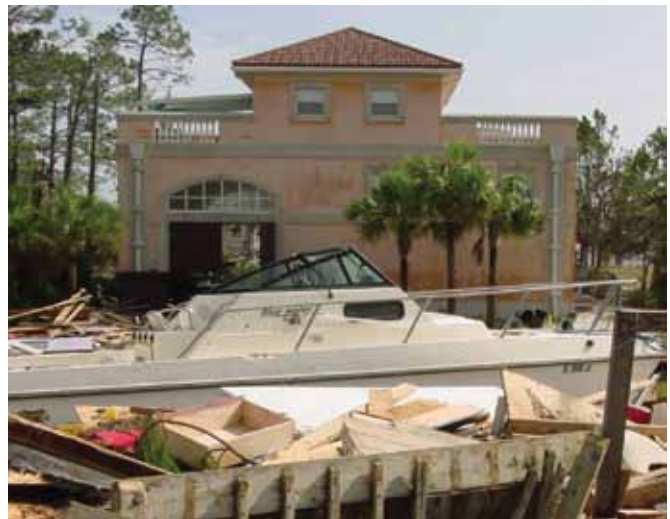
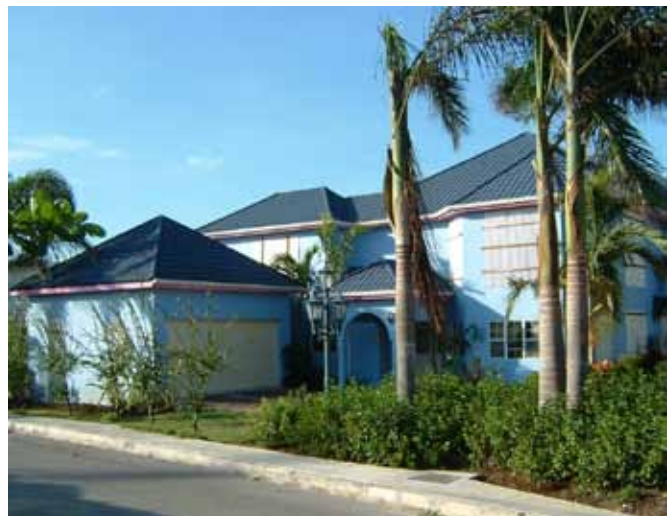
Hurricane Ivan 2004

The storm proved to be a true testament to Gerard’s Stone Coated Steel Roof Systems. There were several homes and other structures that had considerable damage, but structures with stone coated steel roofs were able to minimize the amount of damage. The benefits of the interlocking designed proved effective. The fastener is applied at the nose and allows the roofing panels to anchor down to the neck giving it additional strength and allows for better protection against wind uplift.

Gerard roofs are backed by a 120 mph wind warranty. Additional performance analysis was performed on Gerard’s roofs at the Hurricane Testing Center in Miami, Florida. As a result, these roofs withstood wind gusts of 170 mph without any damage.

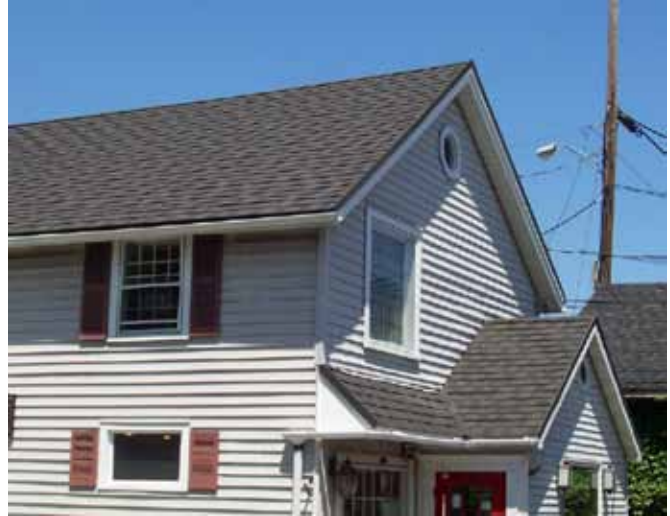
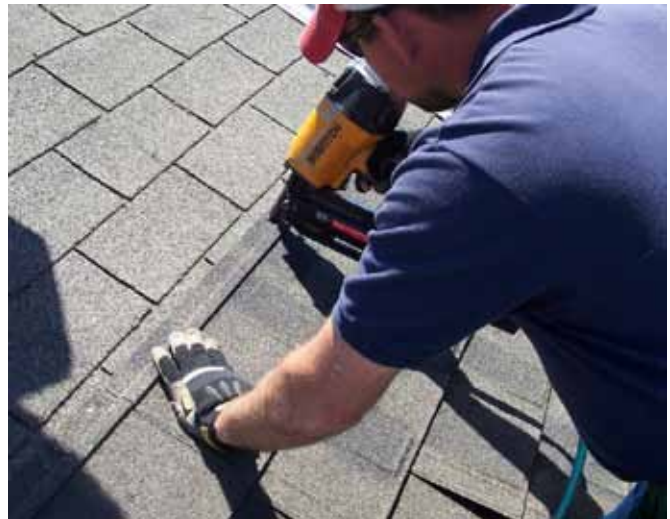
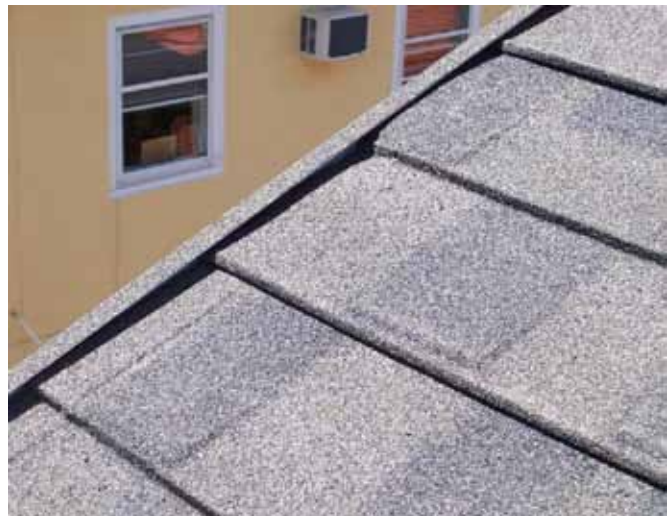
Commercial Re-Roof

The installation was performed by Pro Nailer Roofing. The Allmet Granite Ridge Shingle was the clear choice for this job because it matched the existing roof, was able to be installed directly over the existing roof eliminating the need for removal of the old roof.

The ability to re-roof over an existing roof without removal of the old roof has many benefits. First, installation costs are lower because of not having to pay for old roof removal; second, the old roof will provide an additional layer of protection to your home or building; and finally, you help protect the environment by not having to discard old materials into landfills.

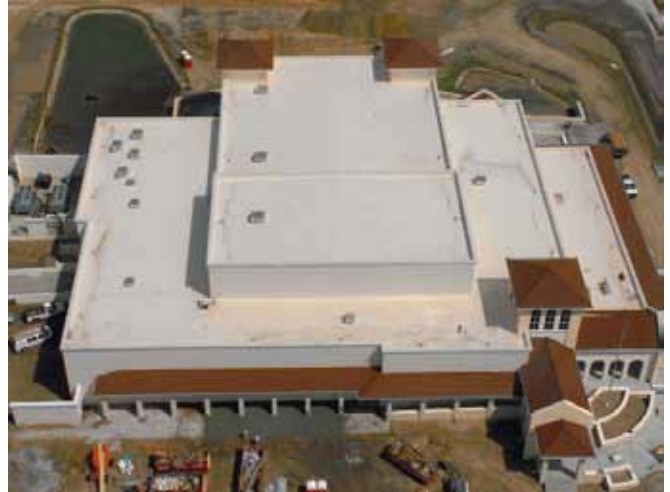
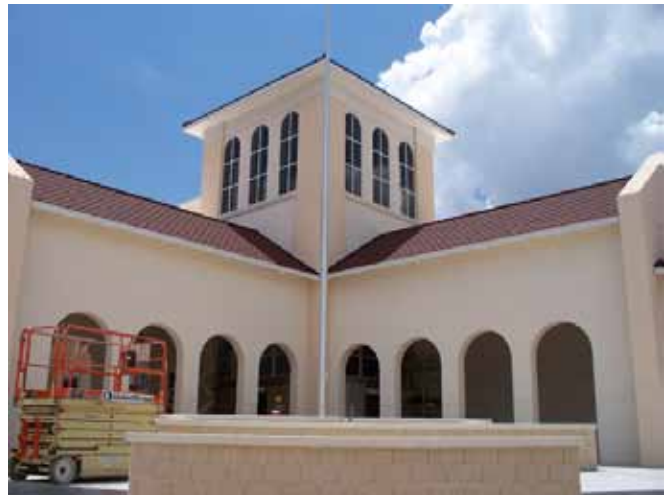
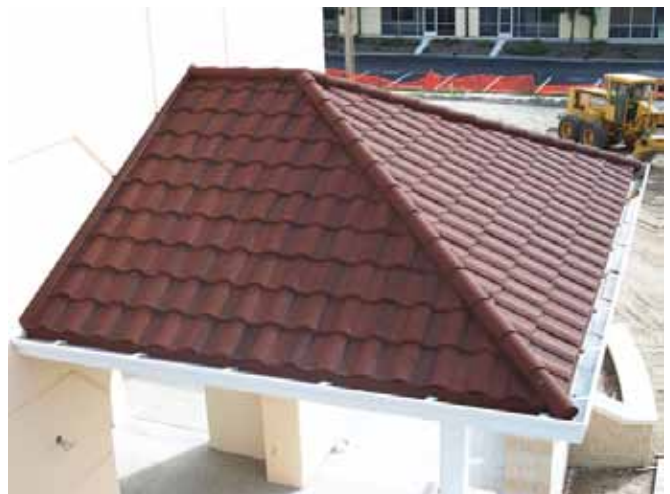
Consumers and businesses alike are turning to energy efficient and more durable building materials to prolong the life of their investments. This was certainly the case with the Charlotte Harbor Event & Conference Center in Punta Gorda, Florida. This area was hit hard by hurricane Charley in 2004 which destroyed The Charlotte County Auditorium creating the need to develop a replacement facility which is now the Charlotte Harbor Event & Conference Center. Located within the jurisdiction of the city of Punta Gorda, Florida, there are some fairly specific design guidelines that are part of their land development regulations. One of the guidelines relates to the architectural style of buildings. Many of the city's acceptable styles are more geared towards the historical residential or commercial architecture that prevails around the downtown area. These styles are characterized by terms like folk Victorian, Craftsman, Queen Anne revival, commercial vernacular, and the like. These styles are not particularly suited to a large civic building like the Event Center. With the help of the city and their Urban Design Staff, Matthew/Taylor Construction's design architect, Harvard Jolly focused on a mission style architecture for the building. This style is one of the preferred styles within the City's design guidelines, there are several notable examples of mission style architecture around the City (e.g. the Historic Train Depot, The Punta Gorda Historical Society Building, and the City's Public Safety Building) and this style is appropriate for a large scale building such as The Charlotte County Event Center.

gles, so the county had additional motivation to use metal roofs on post-Charley buildings. This created a slight problem as mission style buildings almost exclusively have barrel tile roofs as one of their strongest features. Matthews/Taylor Construction and Harvard Jolly ran into the issue of creating a mission style building but with the benefits and survivability of a metal roof.

The solution was simple, utilize a metal roof product that mimics the appearance of a barrel tile roof. There are numerous systems available from a variety of manufactures. While they all have a barrel tile profile of one form or another some of the systems look very different than a true tile roof or look like metal roofs in the shape of tile, but bear very little resemblance to a clay barrel tile that you might expect on a mission style building. After further consultation with the city recommended Matthews/Taylor Construction and Harvard Jolly look at the Gerard Stone Coated Steel Roofing products by Metals USA. The city had recently modified their architectural building codes that mandated tile roofs in certain areas of the city to allow products like the Gerard Stone Coated Steel Roof system to be installed. This code modification was a direct result of the poor performance of the clay and cement tile roofs during Charley and was an attempt to keep the look of tile in these areas, while giving options for a system that they hoped would offer better performance in a future storm, and result in less wind-borne projectiles.

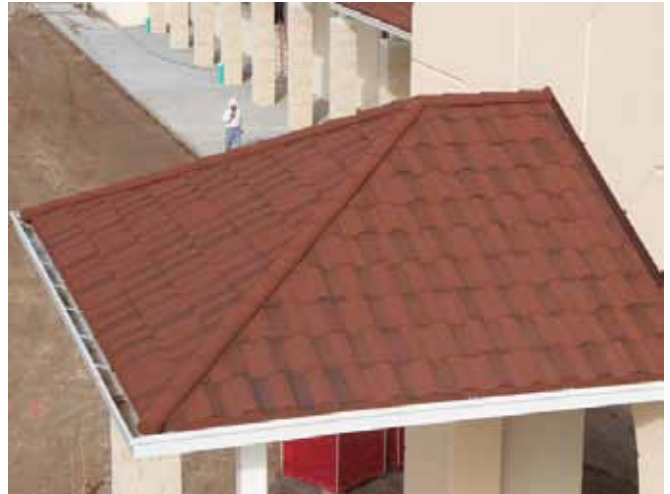
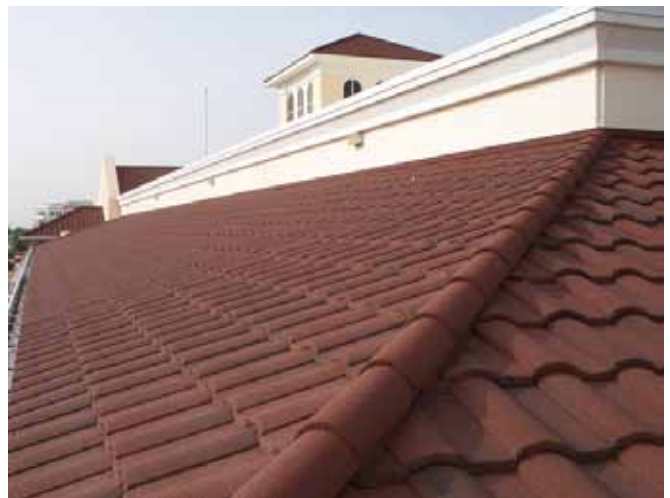
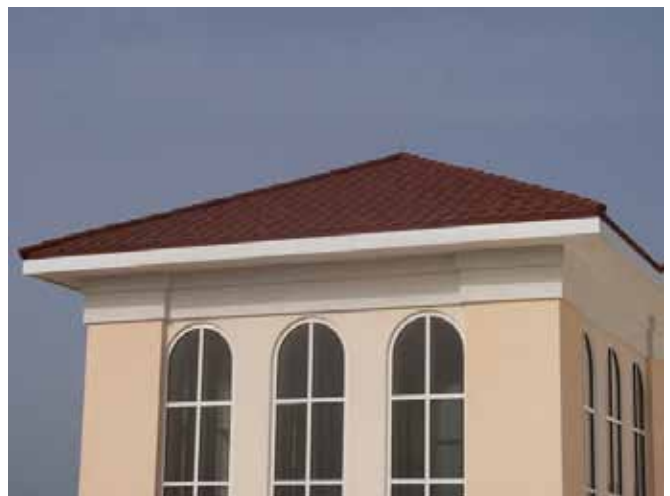
The Gerard Stone Coated Steel Roof products were reviewed and ultimately selected as the roofing product of choice that met all the city's requirements as well as maintain the goal of creating a mission style building. The Gerard Barrel Vault profile with the Cyrus color now completes The Charlotte County Event & Conference Center.

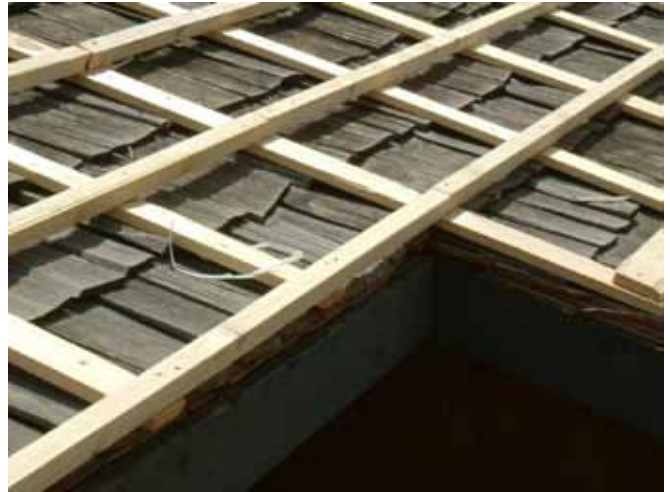
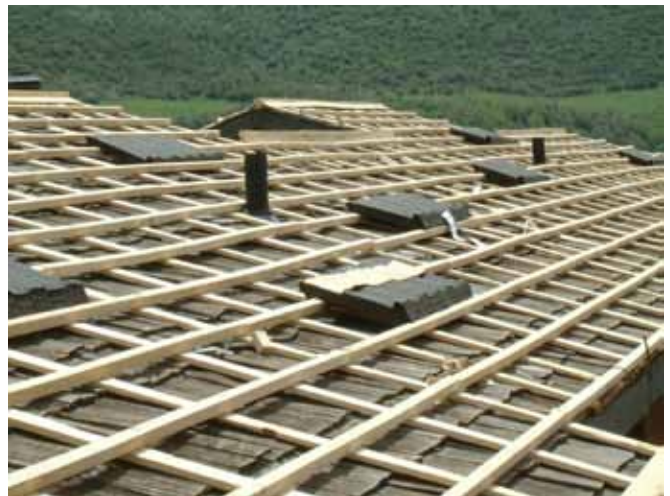
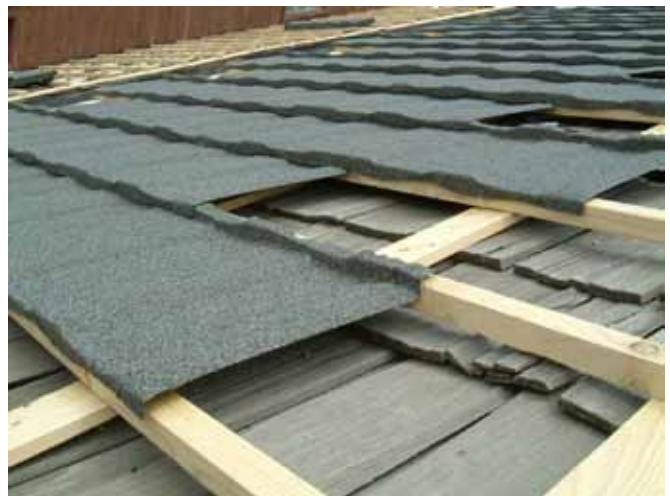
Batten & Counter Batten Study

- The control deck was covered in dark gray asphalt shingles applied direct to deck.
- One deck was painted metal and fastened direct to deck.
- Two decks were stone coated steel with dark gray conventional (no IR-blocking granules) on batten and/or counter batten systems
- Six decks were stone coated steel with light gray IR-Pigment granules and applied on batten or counter batten systems. Venting was achieved with mesh-covered opening at the eave and at the ridge.

- IR-Pigments returned expected results. Heat transfer was reduced by approximately 45 percent when compared to the control deck or asphalt shingles. However, only 15 percent could be attributed to batten/counter batten installations, or over the deck venting.

- When the decks coated with conventional dark gray granules (similar in reflectance and emittance to the asphalt shingles) were compared to the control deck (asphalt shingles) heat transfer was still reduced by the venting created with the batten/counter batten installation

- When the light gray IR-Pigment stone coated panels were compared to the dark gray conventional stone coated panels (both installed on a batten and counter batten system), it was noted that the panels with the dark gray conventional granules swept away more than twice the amount of heat flow than the IR-pigment granular coated panels: the heat produced by the darker pigment granules increased the amount of hot air swept away from the deck, preventing it from entering the attic.
